**Flood Control Project Maintenance  
Levee Inspections**

**Maintenance Issue Types Only, Levee Inspection Report By Mile - Fall 2015**

**Sacramento Maintenance Yard Maintenance Area 0004**

Waterway	Bank	Unit Miles	Inspection Start/End	Inspector
Unit No. 01 Sacramento River	Right	3.47	09/17/2015 09/17/2015	Jai Lor

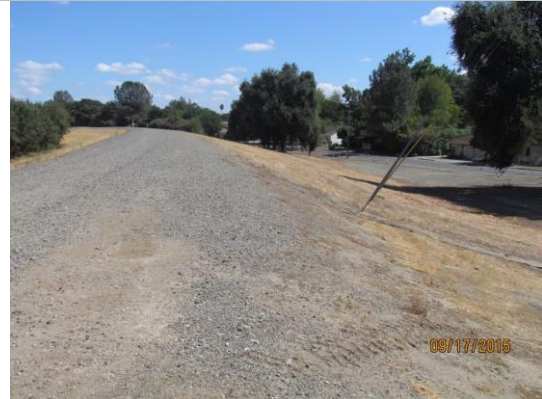
Photo 1 of 1 : FA\_2015\_MA0004\_298\_6\_20150921\_00019.jpg

LM Start	0.00	Rating **	A	Issue No.	6
LM End	3.03	Issue Type +	Ma	Location *	LS
Category	Earthen Levee			GPS Latitude/Longitude	
				Start	End
Item	Vegetation			38.596817 °	38.587186 °
				-121.547525 °	-121.508022 °
DWR ID	DWR_MA0004_01_f _ 2015_6				
Action/Comments					
Control annual grass and weeds on the levee slopes and easements. Inspector Comments: Vegetation on the slope has been mowed and there is no visibility obstruction.

View of the vegetation on the landward side of the levee looking downstream. Fall 2015.

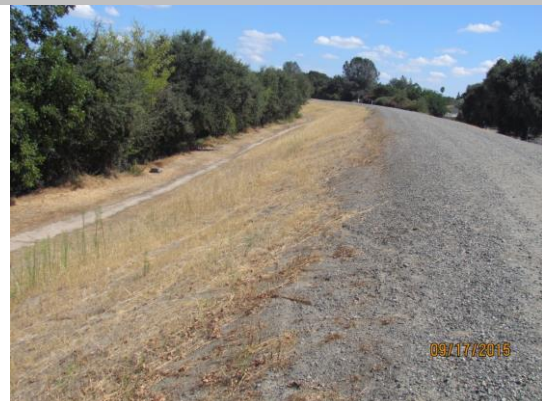
Photo 1 of 1 : FA\_2015\_MA0004\_298\_1\_20150921\_00018.jpg

LM Start	0.00	Rating **	A	Issue No.	1
LM End	3.03	Issue Type +	Ma	Location *	WS
Category	Earthen Levee			GPS Latitude/Longitude	
				Start	End
Item	Vegetation			38.596817 °	38.587185 °
				-121.547524 °	-121.508022 °
DWR ID	DWR_MA0004_01_f _ 2015_1				
Action/Comments					
Control annual grass and weeds on the levee slopes and easements. Inspector Comments: Vegetation on the slope has been mowed and there is no visibility obstruction.

View of the vegetation on the waterward side of the levee looking downstream. Fall 2015.

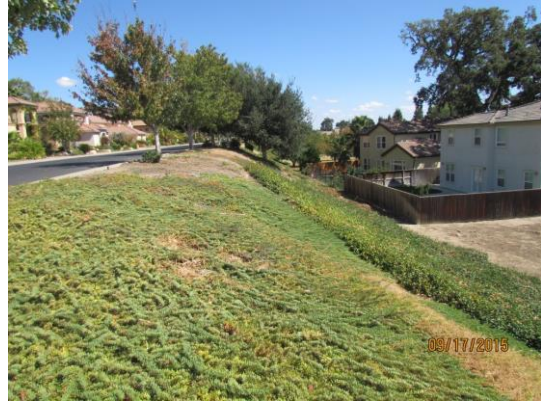
Photo 1 of 1 : FA\_2015\_MA0004\_298\_7\_20150921\_00021.jpg

LM Start	1.34	Rating **	A/W	Issue No.	7
LM End	1.97	Issue Type +	Ma	Location *	LS
Category	Earthen Levee			GPS Latitude/Longitude	
				Start	End
Item	Vegetation			38.602756 °	38.600449
				-121.525618 °	-121.514459
DWR ID	DWR_MA0004_01_s_2012_7				
Action/Comments					
Landscaping					
Inspector Comments: The Rivers housing development

View of the landscaping on the landward side of the levee looking downstream. Fall 2015.

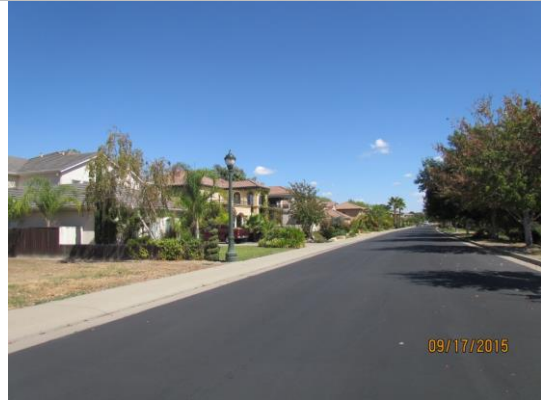
Photo 1 of 1 : FA\_2015\_MA0004\_298\_8\_20150921\_00022.jpg

LM Start	1.35	Rating **	A/W	Issue No.	8
LM End	1.51	Issue Type +	Ma	Location *	CR
Category	Earthen Levee			GPS Latitude/Longitude	
				Start	End
Item	Encroachments			38.602764 °	38.602596 °
				-121.525319 °	-121.522439 °
DWR ID	DWR_MA0004_01_s_2012_8				
Action/Comments					
Building					
Inspector Comments: The Rivers housing development houses on crown of levee waterside

View of the houses on the crown of the levee looking downstream. Fall 2015.

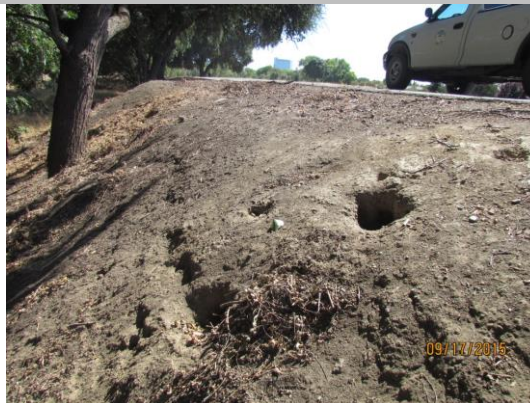
Photo 1 of 1 : FA\_2015\_MA0004\_298\_18\_20150921\_00024.jpg

LM Start	2.12	Rating **	M	Issue No.	18
LM End	2.12	Issue Type +	Ma	Location *	WS
Category	Earthen Levee			GPS Latitude/Longitude	
				Start	End
Item	Animal Control			38.598613 °	38.598613 °
				-121.513012 °	-121.513012 °
DWR ID	DWR_MA0004_01_f _ 2015_18				
Action/Comments					
No rodents visible, but rodent burrows visible; need to backfill and compact or grout burrows.

View of the animal holes on the waterward side of the levee looking downstream. Fall 2015.

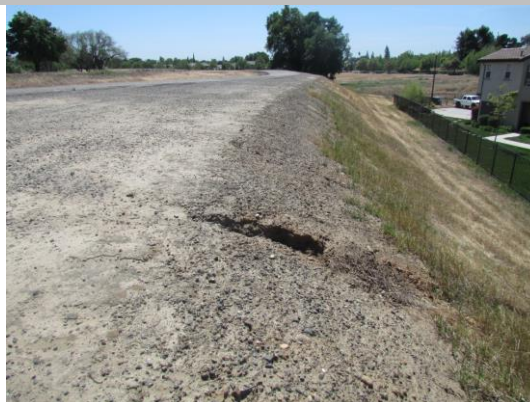
Photo 1 of 1 : FA\_2015\_MA0004\_298\_13\_20150914\_00012.jpg

LM Start	2.18	Rating **	M	Issue No.	13
LM End	2.18	Issue Type +	Ma	Location *	LS
Category	Earthen Levee			GPS Latitude/Longitude	
				Start	End
Item	Erosion / Bank Caving			38.597967 °	38.597967 °
				-121.512892 °	-121.512892 °
DWR ID	DWR_MA0004_01_s _ 2015_13				
Action/Comments					
Schedule repair of erosion site prior to the next inspection.

View of the erosion on the landward side of the levee looking downstream. Spring 2015.

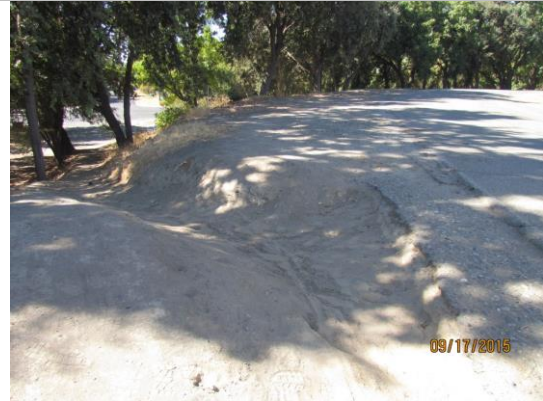
Photo 1 of 1 : FA\_2015\_MA0004\_298\_22\_20150921\_00026.jpg

LM Start	2.65	Rating **	M	Issue No.	22
LM End	2.65	Issue Type +	Ma	Location *	LS
Category	Earthen Levee			GPS Latitude/Longitude	
				Start	End
Item	Slope Stability			38.591380 °	38.591380 °
				-121.511345 °	-121.511345 °
DWR ID	DWR_MA0004_01_f _ 2015_22				
Action/Comments					
Repair the levee slope damaged by foot traffic and prevent access where possible.

View of the depression on the landward side of the levee due to foot traffic looking upstream. Fall 2015.

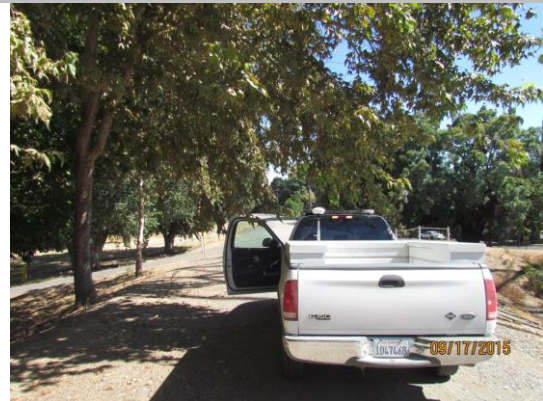
Photo 1 of 1 : FA\_2015\_MA0004\_298\_23\_20150921\_00027.jpg

LM Start	2.76	Rating **	M	Issue No.	23
LM End	2.76	Issue Type +	Ma	Location *	CR
Category	Earthen Levee			GPS Latitude/Longitude	
				Start	End
Item	Trim / Thin Trees			38.590248 °	38.590248 °
				-121.509940 °	-121.509940 °
DWR ID	DWR_MA0004_01_f _ 2015_23				
Action/Comments					
Trim trees over roadway to at least 12 feet above ground level.

View of the tree branches on top of the crown of the levee looking downstream. Fall 2015.

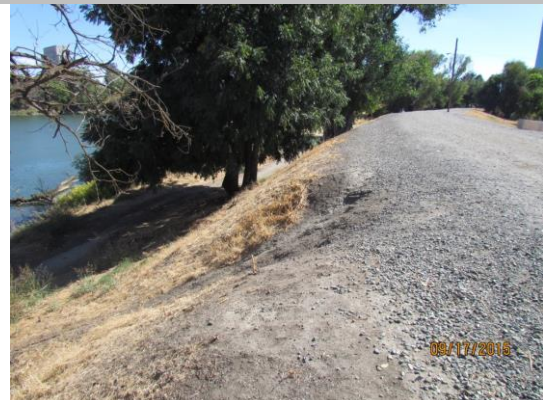
Photo 1 of 1 : FA\_2015\_MA0004\_298\_24\_20150921\_00028.jpg

LM Start	2.91	Rating **	M	Issue No.	24
LM End	2.91	Issue Type +	Ma	Location *	WS
Category	Earthen Levee			GPS Latitude/Longitude	
				Start	End
Item	Slope Stability			38.588937 °	38.588937 °
				-121.507920 °	-121.507920 °
DWR ID	DWR_MA0004_01_f _ 2015_24				
Action/Comments					
Repair the levee slope damaged by foot traffic and prevent access where possible.

View of the slope stability due to foot traffic on the waterward side of the levee looking downstream. Fall 2015.

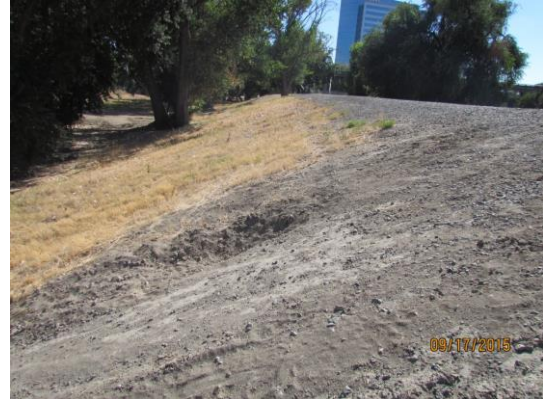
Photo 1 of 1 : FA\_2015\_MA0004\_298\_25\_20150921\_00029.jpg

LM Start	2.97	Rating **	M	Issue No.	25
LM End	2.97	Issue Type +	Ma	Location *	WS
Category	Earthen Levee			GPS Latitude/Longitude	
				Start	End
Item	Slope Stability			38.587998 °	38.587998
				-121.507896 °	-121.507896
DWR ID	DWR_MA0004_01_f _ 2015_25				
Action/Comments					
Repair slope instability.

View of the depression on the waterward side of the levee looking downstream. Fall 2015.

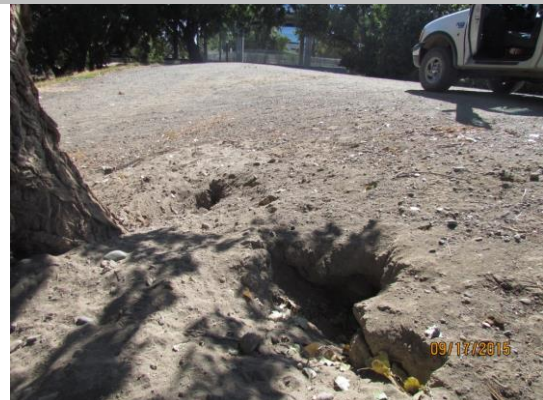
Photo 1 of 1 : FA\_2015\_MA0004\_298\_26\_20150921\_00030.jpg

LM Start	3.01	Rating **	M	Issue No.	26
LM End	3.01	Issue Type +	Ma	Location *	WS
Category	Earthen Levee			GPS Latitude/Longitude	
				Start	End
Item	Animal Control			38.587406 °	38.587406 °
				-121.507991 °	-121.507991 °
DWR ID	DWR_MA0004_01_f _ 2015_26				
Action/Comments					
No rodents visible, but rodent burrows visible; need to backfill and compact or grout burrows.

View of the animal hole on the waterward side of the levee looking downstream. Fall 2015.

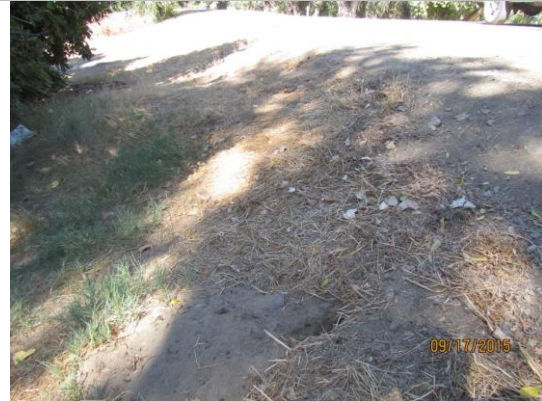
Photo 1 of 1 : FA\_2015\_MA0004\_298\_3\_20150921\_00031.jpg

LM Start	3.03	Rating **	M	Issue No.	3
LM End	3.03	Issue Type +	Ma	Location *	LS
Category	Earthen Levee			GPS Latitude/Longitude	
				Start	End
Item	Animal Control			38.587135 °	38.587135 °
				-121.508093 °	-121.508093 °
DWR ID	DWR_MA0004_01_f _ 2015_3				
Action/Comments					
No rodents visible, but rodent burrows visible; need to backfill and compact or grout burrows. Inspector Comments: There are holes in the surrounding area that are hidden by vegetation.

Rodent holes are still visible on the landward side of the levee. Photo taken looking upstream. Fall 2015.
